May 16, 2011

Public Safety Building

Evaluation

City of Ishpeming
100 East Division St
Ishpeming, MI 49849

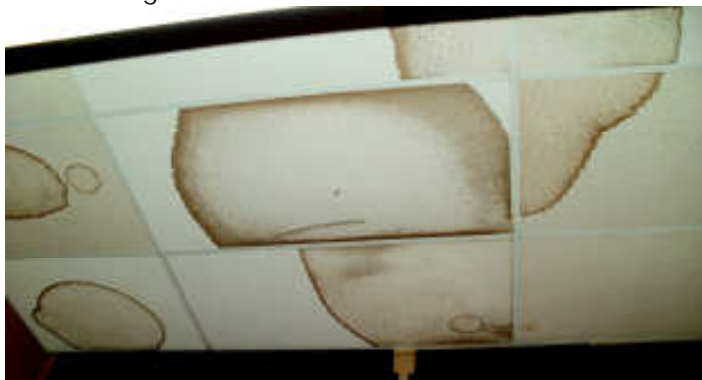
Our investigation found that that roof leakage caused water stained ceiling tile in several areas of the building. On the second floor, a leak occurred that has stained the ceiling tile in the hallway

below the siren cupola. On the first floor water leaks occur above the Police Chief's office at the location of a former roof penetration. Water staining of the wood ceiling joists was observed at this location. Water staining due to roof drain leakage was also observed on the north side of the tower where the block walls were water stained.

The existing roof system has aged beyond its expected life. There is evidence of water damage on the First and Second Floors indicating that the roof has deteriorated. It is recommended that the roof system, including roof membrane, flashings, and drains, be replaced. The existing roof materials and existing insulation should be removed. The existing built-up roof system does contain asbestos and will require special removal procedures and disposal. The roof deck should be examined and repaired as required. Roof openings should be evaluated and any unnecessary openings should be removed and infilled. All roof drains should be replaced. Adequacy of the drainage systems including the addition of overflow drains should also be considered. A new EPDM or PVC membrane roof system is recommended. The roof area is approximately 6,400 s.f.

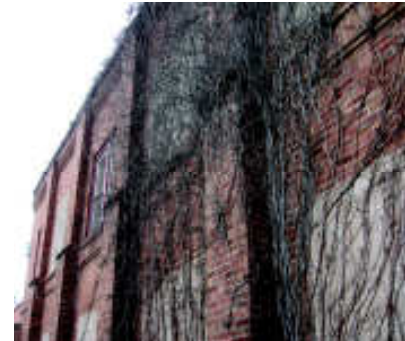
The face brick appears to be in good condition in most areas of the building. It is estimated that approximately 1/3 of the mortar joints need tuckpointing. Several areas were observed with 1/8 inch cracking along mortar joints near the northwest corner of the building. Several of the windows on the south wall of the building were eliminated and the openings filled in with concrete block. There are vines growing on the south and east façades of the building. The condition of the masonry in these areas was not readily visible, however vines typically anchor into the mortar joints, damaging them, and allowing water to penetrate through the brick facade.

Removal of all of the vines growing on the building exterior is recommended. The vine growth will damage the brick and mortar surfaces resulting in further facade deterioration.

Tuckpointing of the exterior masonry is recommended. It is estimated that approximately 1/3 of masonry exterior will need tuckpointing. The entire façade includes approximately 7,570 s.f.

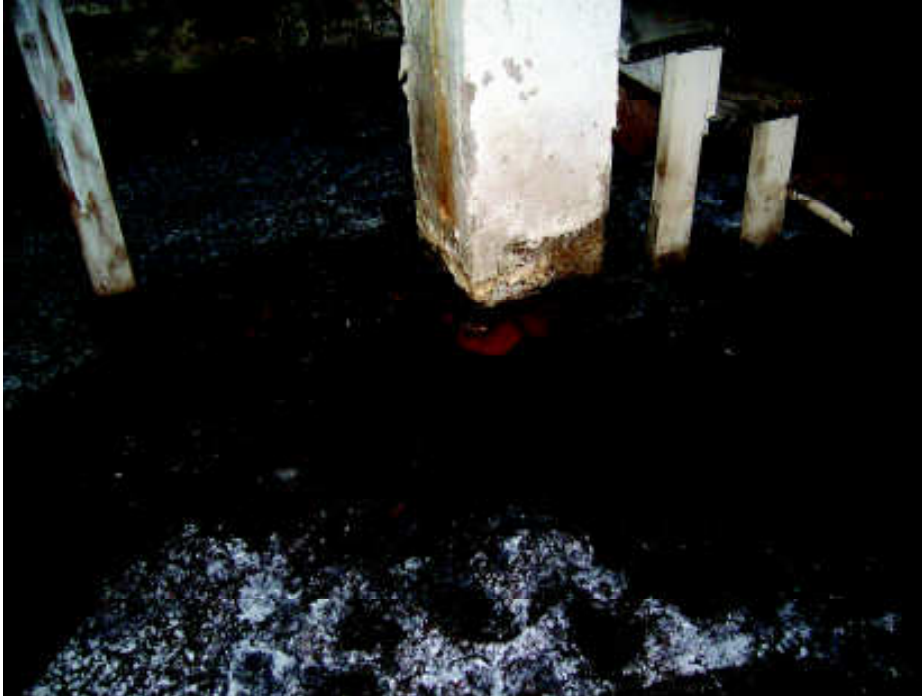
The basement is presently used as a boiler room, a place to store bicycles that have been abandoned within the City, and an exercise area. Much of the basement area is unused due to the damp condition. Water was observed penetrating the floor slab in several areas at columns and along the outside walls of the building. At the base of the stairs to the first floor, groundwater was

seen bubbling up along the edge of a concrete column to the concrete floor slab. A dark colored soil with a texture similar to peat moss was observed on the floor between the column and the floor drain near the northeast corner of the building. There was also a trace of light brown colored soil near the column. It appears that soil has been pumped up from under the floor slab. The fire department commented that this has been an on going problem. The soil is cleaned up before it blocks the floor drains. The floor drain piping has been checked out by the City. Blockage of the piping is not evident. Water was observed on the

floor along the north wall of the building. A sump pump was located in the basement but did not appear to operate when it was turned on.

Drain tile may be required in order to control the groundwater along the perimeter of the building. The drain tile would need to be placed above the bottom of the footings to prevent undermining of the footings. It is recommended that drain tile be placed along the north wall of the building. If groundwater continues to be a problem after installing drain tile along the north side of the building, the entire perimeter of the building will need drain tile.

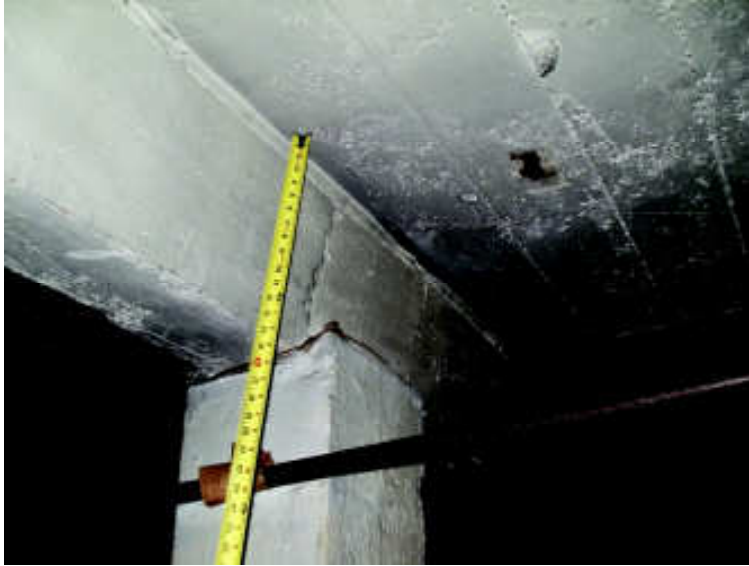
The floor system of the Fire Hall is supported by beams, columns, and a reinforced concrete slab system that is visible from the basement. The floor system appears to have been constructed per

the original design plans and consists of 12' square concrete columns supporting steel beams, which are encased in concrete, and a 6" steel reinforced concrete slab that spans between the beams. The span of the slab system is approximately 12' between beams.

Structural calculations, based on assumptions regarding reinforcing size, frequency, and placement and concrete strength, indicate that the existing slab is not adequate to support the weight of present day fire equipment. The maximum recommended loading of the slab,

should it meet the assumptions, is 100p.s.f. of working live load. See Appendix A for the structural analysis of the slab.

The existing floor system is not adequate to support the present day fire equipment. The addition of new larger equipment will only increase the loading on the floor system. If the floor system continues to be used to store large vehicles, it needs to be reinforced to bring the floor within acceptable loading limits.

It is recommended that steel beams and columns be installed in the basement area to reduce the concrete slab spans. New beams and columns should be installed at the midpoints of the existing spans to reduce the effective spans to approximately 6'. It should be noted that the modifications of the span lengths will affect the existing structural system and may result in some cracking of the slab above the existing beams.
